**An Assessment of Trails, Watercourses, Soils, and Redwood  
Forest Health in Joaquin Miller Park, Oakland, California,  
with Recommendations for Management**

Submitted to:

City of Oakland  
Office of Parks and Recreation  
1520 Lakeside Drive  
Oakland, California 94612

December 31, 2000

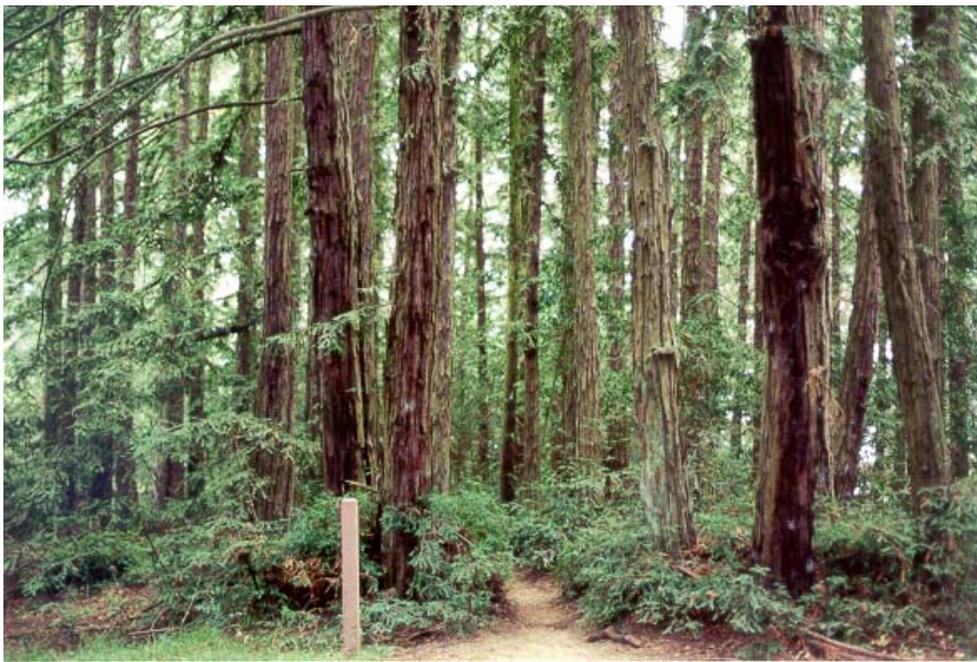
No extraordinary conditions were observed with regard to tree vigor, mechanical damage, and tree pathogens. No areas showed signs of declining vigor. One area was noted, however, that was observed to be a poorer growing site than other areas of the Park. This area is located on a ridge along the Big Trees Trail and is identified as Area “I” on Figure 1. The redwood trees in this area are of much smaller diameters than in other areas of the Park, and they exhibit a shaggy bark condition that is more pronounced than seen on other trees of the Park (see Figure 2).

**Figure 2:** Area “I” of the Big Trees Trail, Harsh Growing Site

Although these trees are smaller on average than other trees of the Park, they are the same age as the other larger redwood trees. This area shows a lower overall tree vigor because it is a harsher growing site, probably due in part to shallower soils, not due to any Park use.

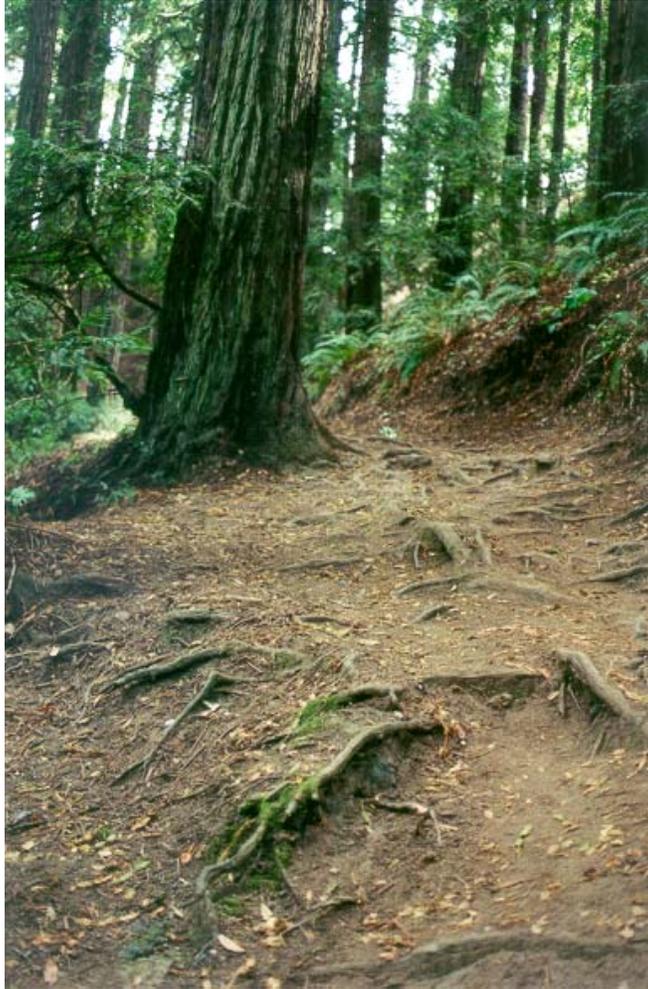
**Figure 3:** Area “K” of the Big Trees Trail west of Sequoia Point

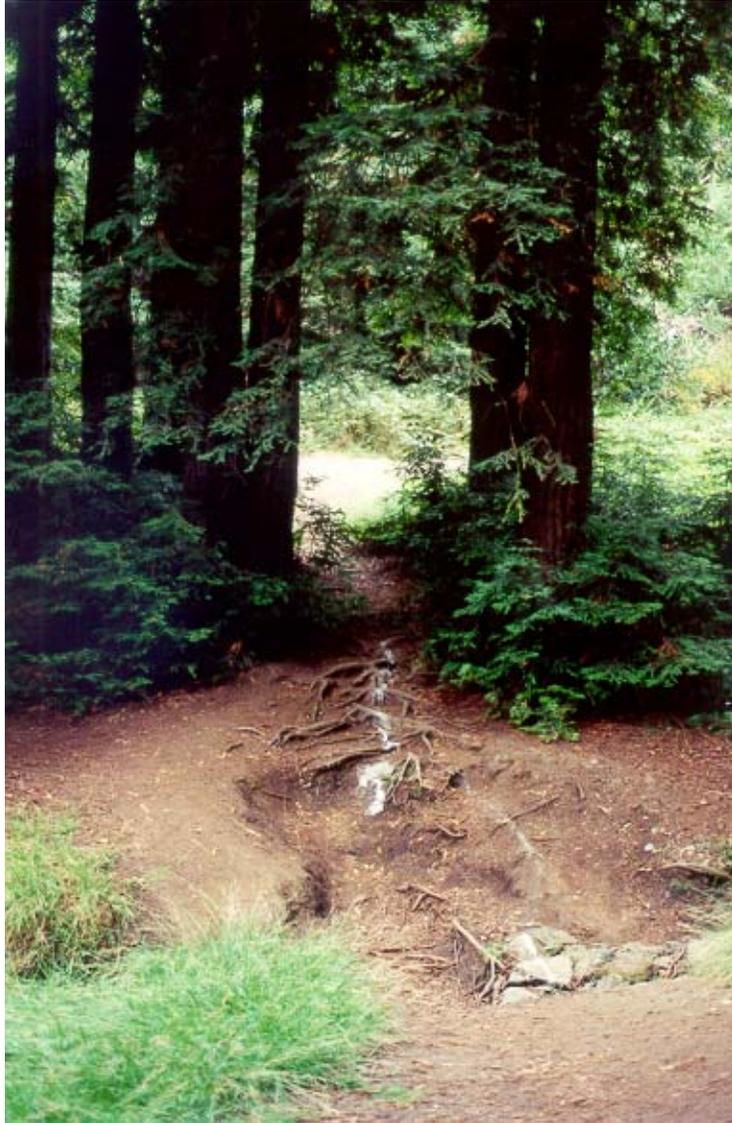
**Figure 4:** Area "K" of the Big Trees Trail at Junction of Sunset Trail

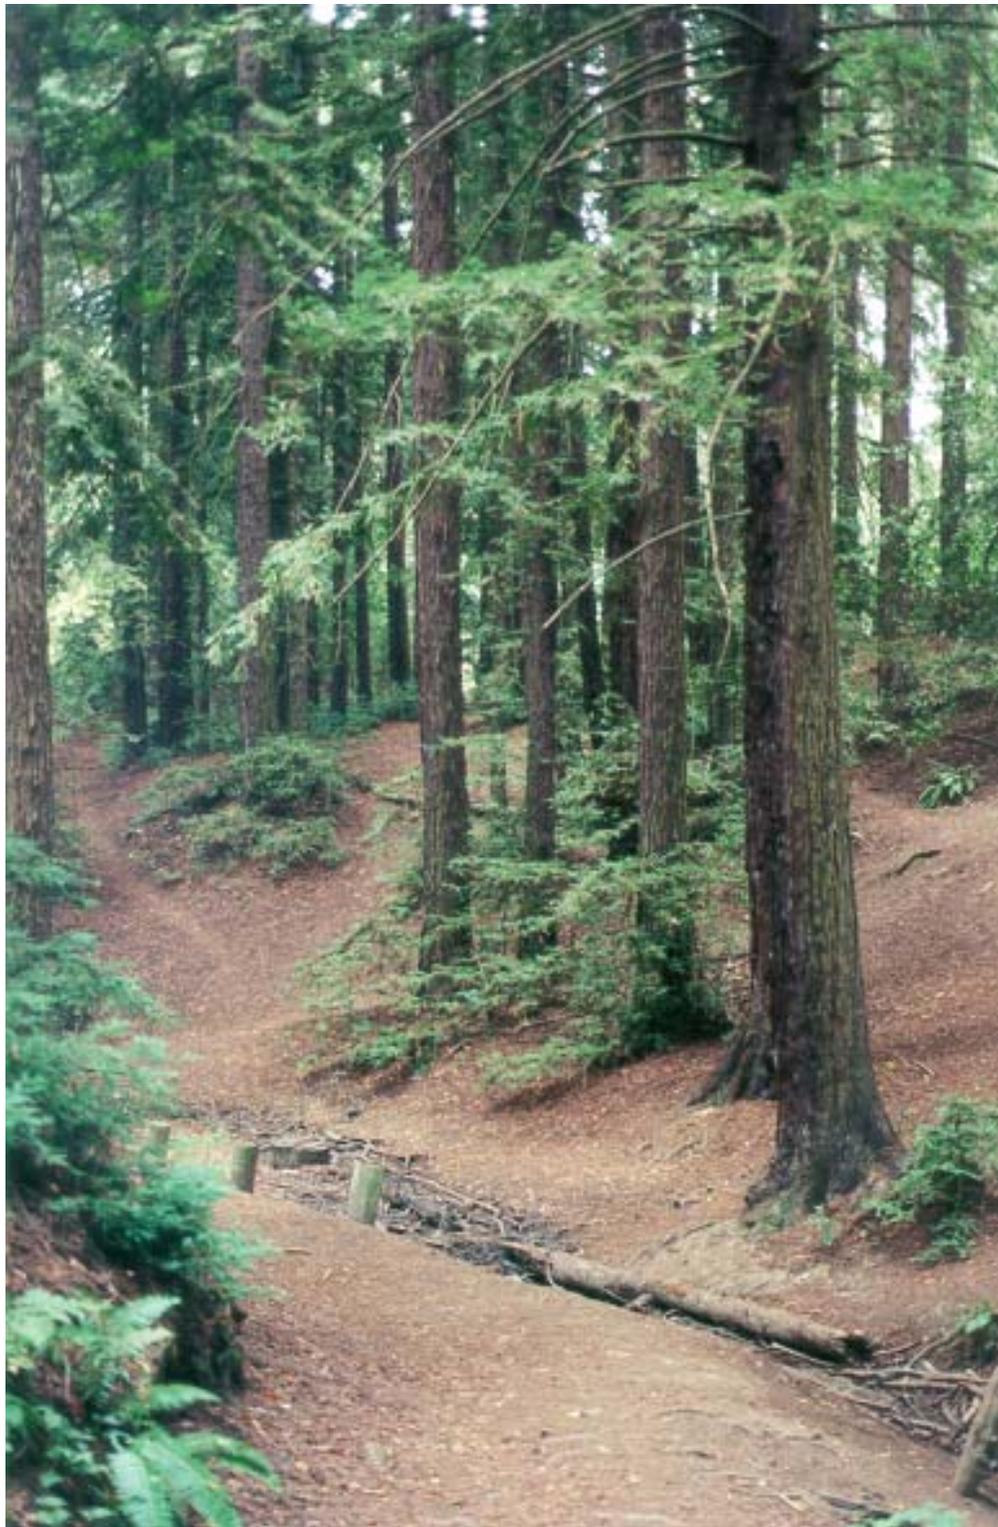
species diversity and native plant components. The vegetation trampling results from all types of off-trail traffic (pedestrian, equestrian, and bicycle) with no distinct difference in degree of impact between the types of off-trail traffic. The off-trail traffic causes direct physical impact to the plants as well as soil compaction, which can be a limiting factor for plants (especially the liliaceous species). Off-trail use was noted throughout the trail system. In particular, the flat and gentle slope areas, such as the ridgeline and spur ridges associated with the Ravine and Big Trees trail areas, were heavily impacted (see Figure 5).

**Figure 5:** Off-Trail Vegetation Trampling Impacts in the Redwood Forest (Ravine trail area).

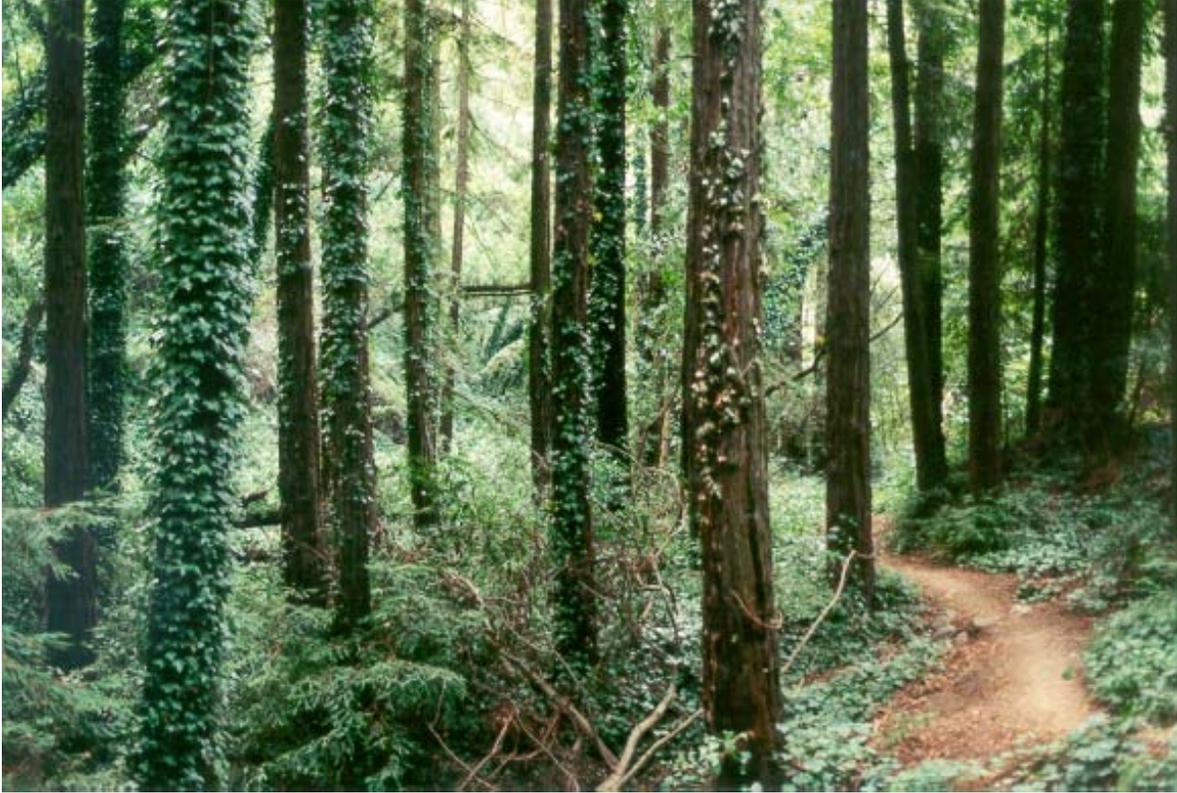
**Figure 6:** English ivy climbing redwood trees (along Palo Seco Creek).

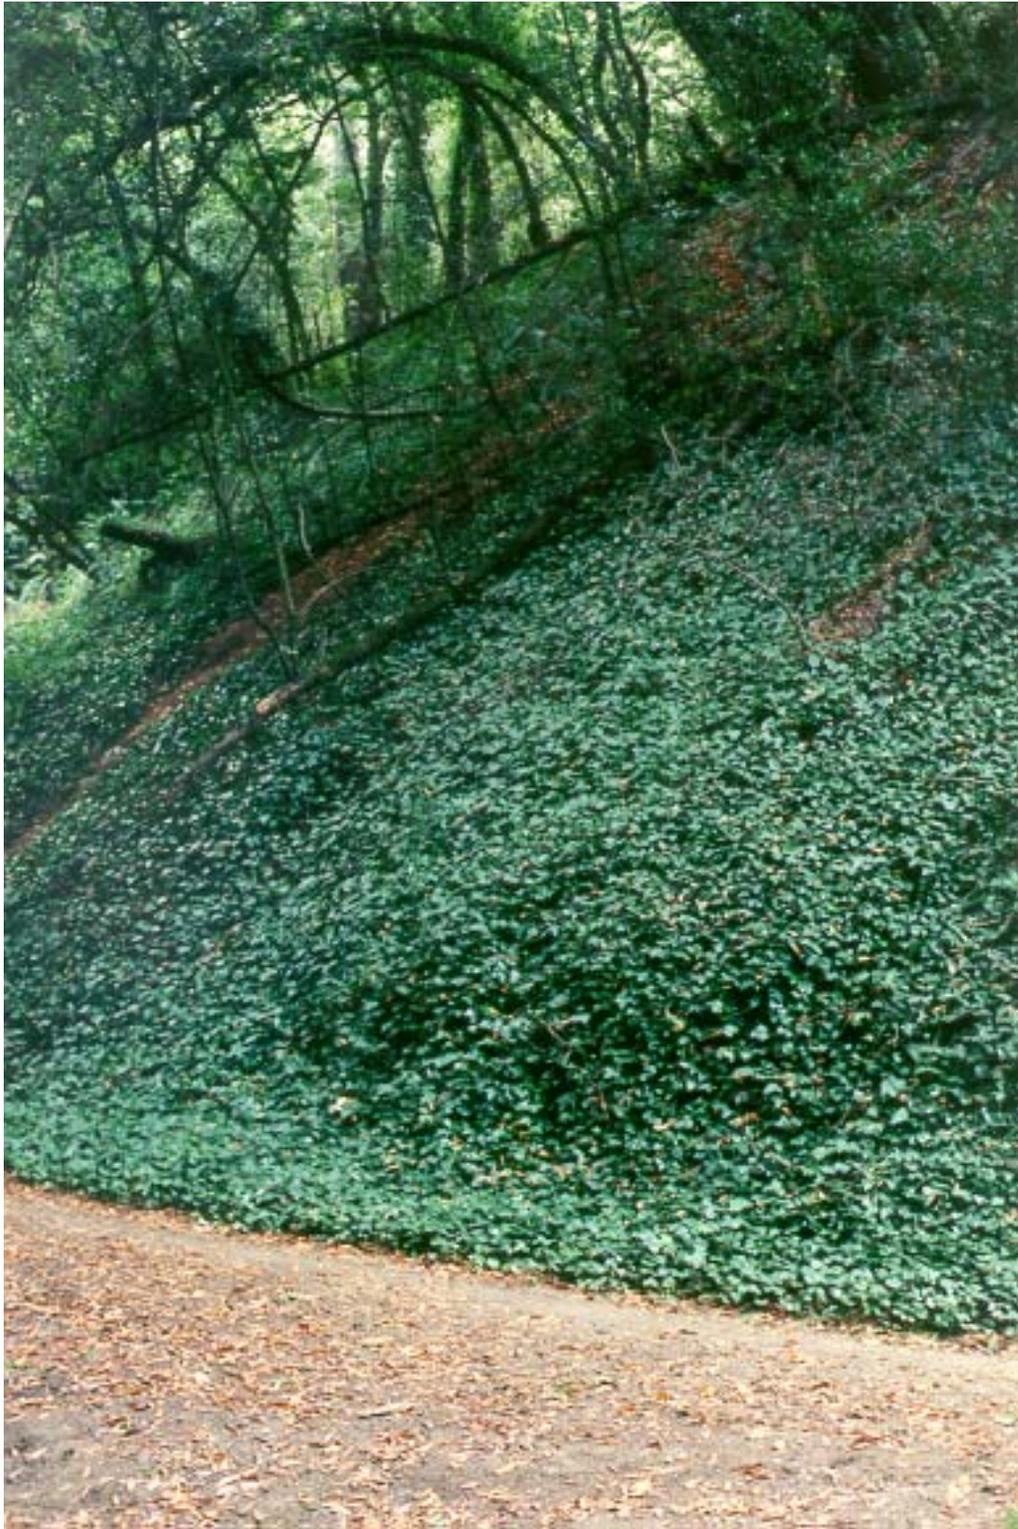
**Figure 7:** English ivy carpeting and smothering the herbaceous layer (along Palo Seco Creek).
